# Inspection Report

## Visionary Holdings

7142 Shannon Blvd

Fort Myers FL 33908

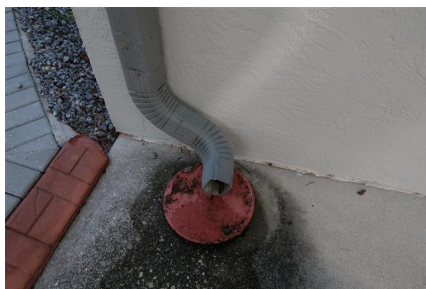
**1.5 Item 1 (Picture)**

One or more downspouts discharged roof drainage next to the foundation. This condition can effect the ability of the soil to support the weight of the structure above and can cause damage related to soil/foundation movement. The Inspector recommends the installation of downspout extensions to discharge roof drainage a minimum of 6 feet from the foundation.

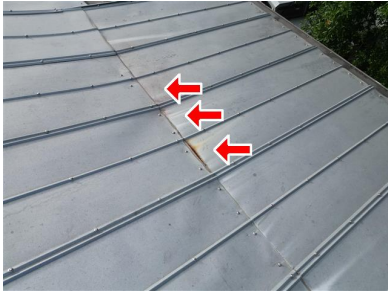
1.6 Item 1 (Picture)

The metal roof was older and exhibited minor amounts of corrosion on right side slope. It appeared to be adequately protecting the structure at the time of the inspection.

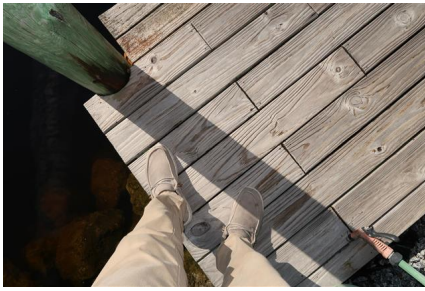
4.1 Item 1 (Picture)

There are areas of loose boards at dock.

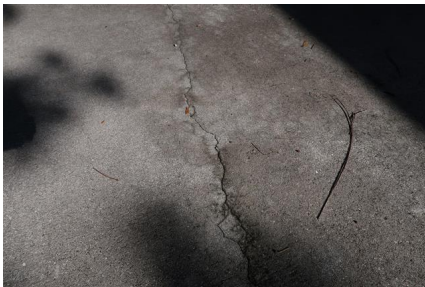
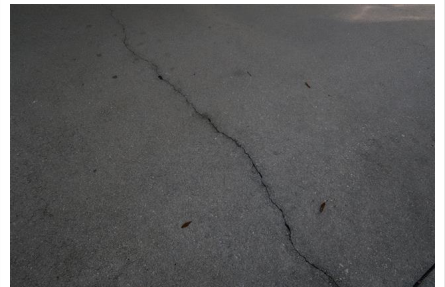
Significant cracks visible in the driveway should be filled with an appropriate sealant to avoid continued damage to the driveway surface from freezing moisture.

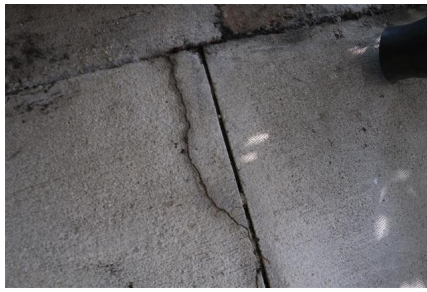
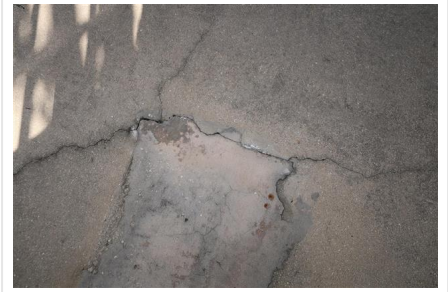
(1) Significant cracks visible in the screened porch should be patched with an appropriate sealant to avoid continued damage from freezing moisture.

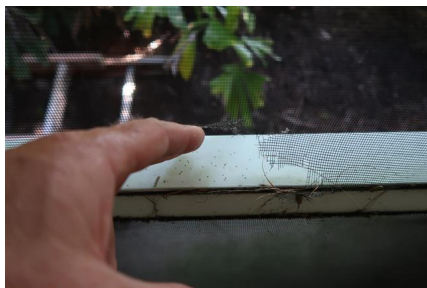
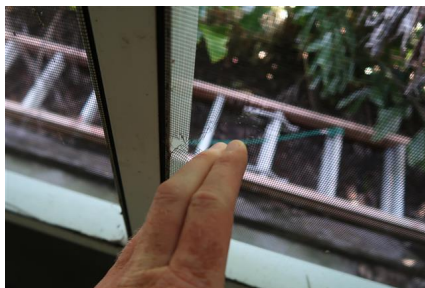
(2) Inspector observed damaged screening at screened in porch. Repairs should be made by a qualified contractor.

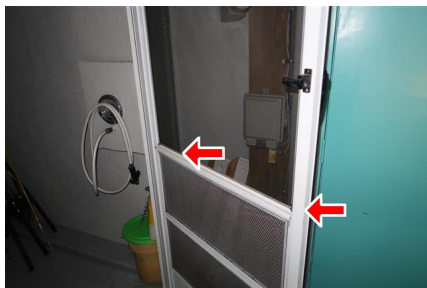
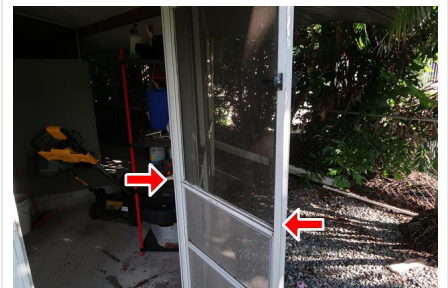
(3) Screened porch doors were missing hardware allowing them to self close. Repairs should be made by a qualified contractor.

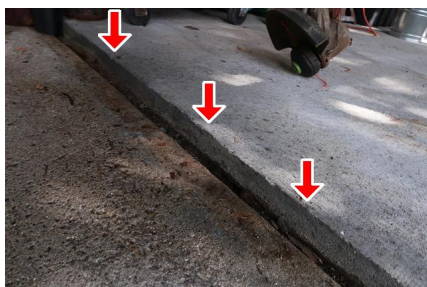
4.6 Item 9 (Picture)

(4) Inspector observed settling visible at screened in porch concrete slab, causing a tripping hazard. Repairs should be made by a qualified contractor.

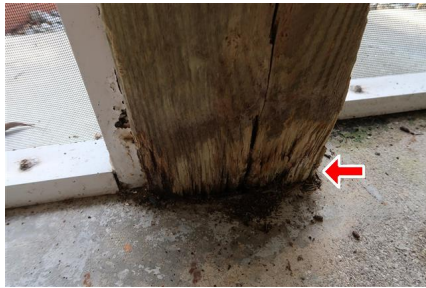
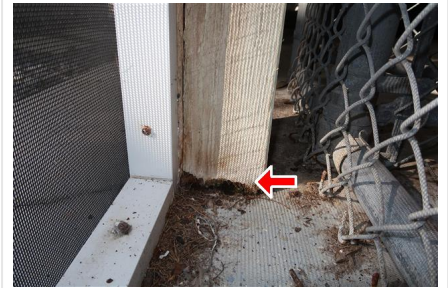
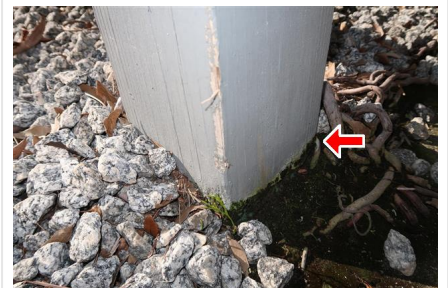
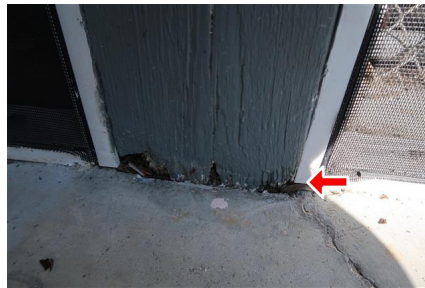
(1) The rear deck framing had advanced decay from contact with soil/moisture. The inspector recommends repair of affected framing to extend the service life of this structure. All work should be performed by a qualified contractor.

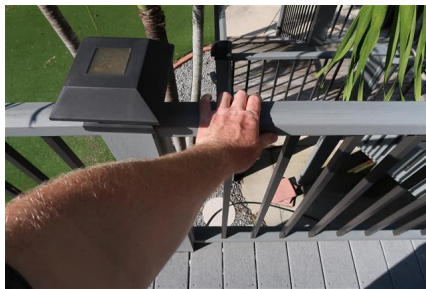
4.7 Item 9 (Picture)

(2) The deck guard rail assemblies were loose and should be made secure by a qualified contractor.

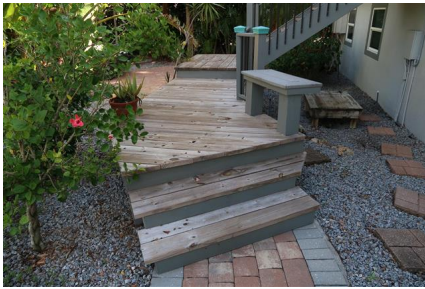
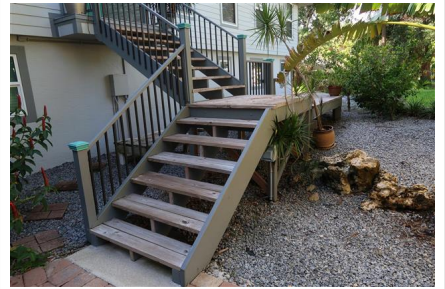
(1) This exterior staircase at front of dwelling had missing handrail. Generally-accepted current safety standards mandate that stairs with 4 or more risers should have a handrail. You should consult with a qualified contractor before the expiration of your Inspection Objection Deadline to discuss options and costs for handrail installation.

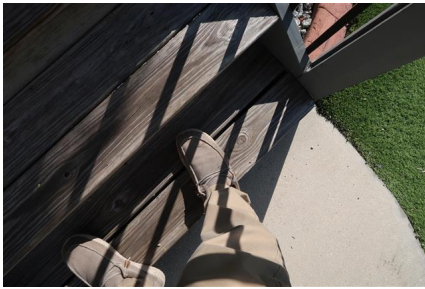
4.8 Item 4 (Picture)

(2) Treads at the rear exterior staircase were loose and needed to be properly secured. This condition is a potential trip hazard. All corrections should be made by a qualified contractor.

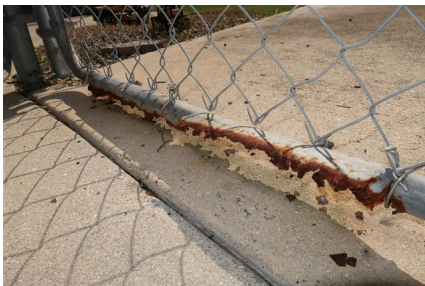
4.9 Item 1 (Picture)

The steel fencing exhibited moderate general corrosion and needed maintenance.

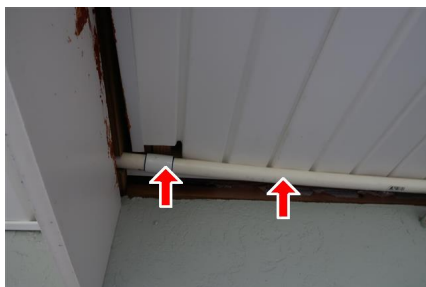
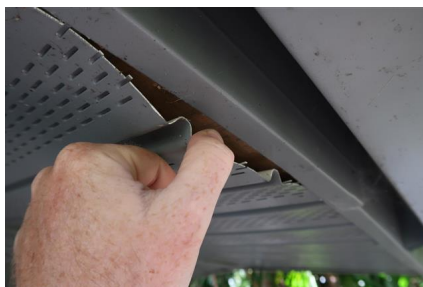
(1) Vinyl soffits at rear side of dwelling was loose and needs re-fastened.

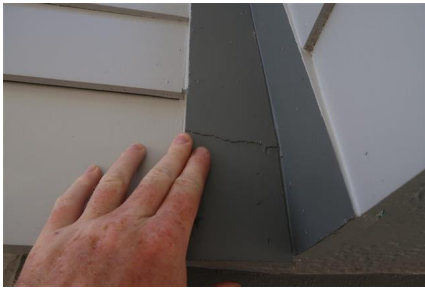
5.3 Item 3 (Picture)

(2) Inspector observed damaged hard hard board trim on right side of dwelling.

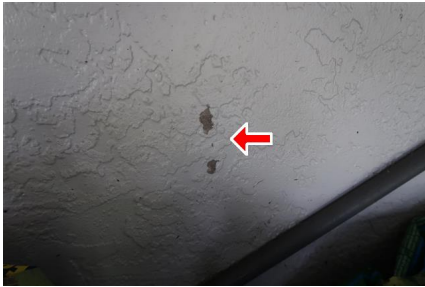
5.4 Item 1 (Picture)

Minor stucco damage at rear side of dwelling.

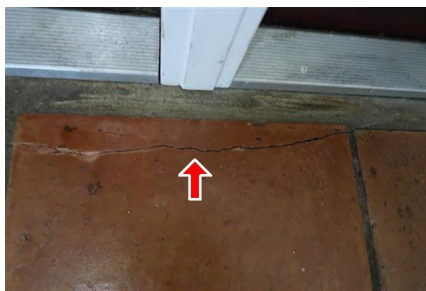
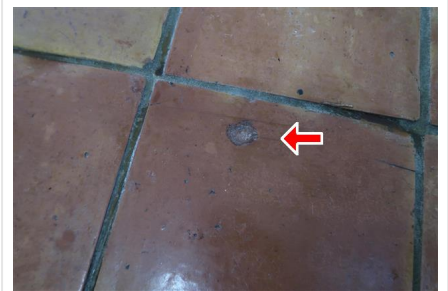
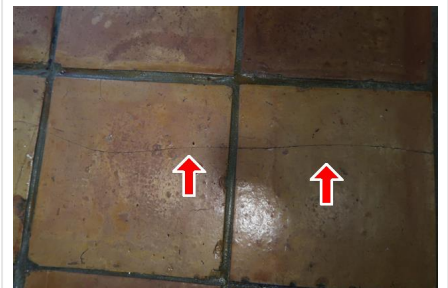
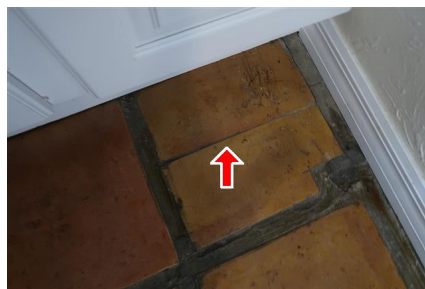
(1) The 2nd floor living area had cracked or damaged floor tiles. You should ask the seller if spare tiles are available as matching replacements. The Inspector recommends that before the expiration of your Inspection Objection Deadline you consult with a qualified contractor to discuss options and costs for replacement.

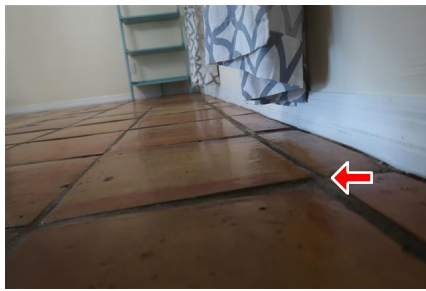
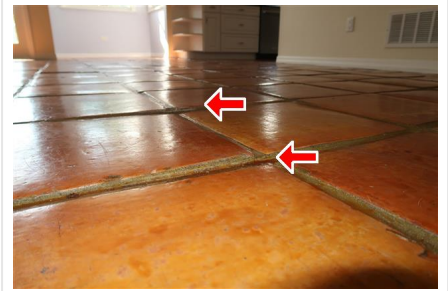
(2) Floor tiles at 2nd floor living area were poorly installed. A number of uneven tiles were observed.

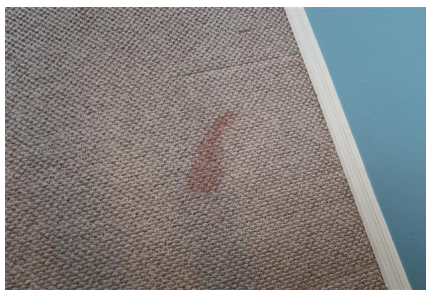
(3) Carpeting in the home was severely worn and stained. The Inspector recommends that before the expiration of your Inspection Objection Deadline you consult with a qualified contractor to discuss options and costs for replacement.

**7.0 Item 12 (Picture)**  
2nd shared bedroom

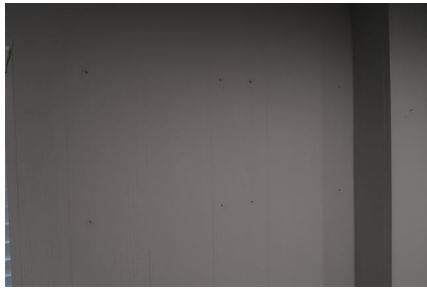
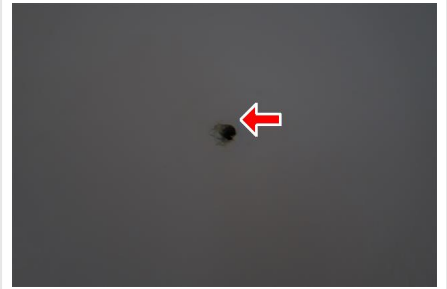
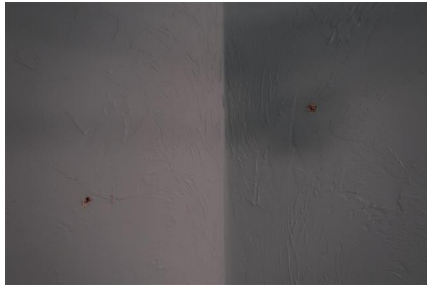
(1) Holes in walls at areas of the dwelling should be patched.

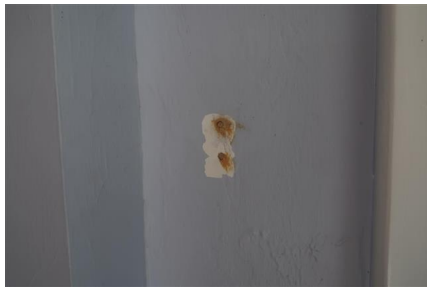
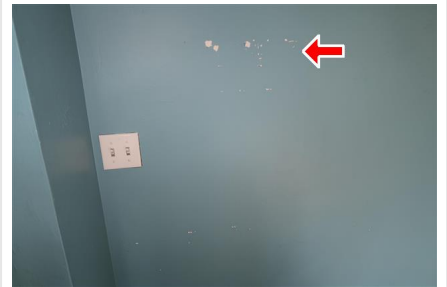
(2) Walls in the home showed general moderate damage. Repairs should be made by a qualified contractor.

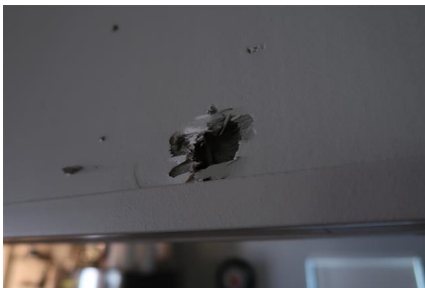
7.2 Item 1 (Picture)

(1) Inspector observed a hole in the siding around flooring joist at ground level living area. Repairs should be made by a qualified contractor.

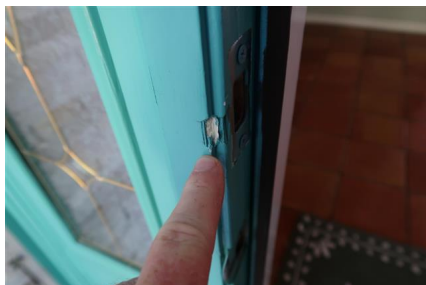
**7.6 Item 1 (Picture)**

Minor damage to front door.

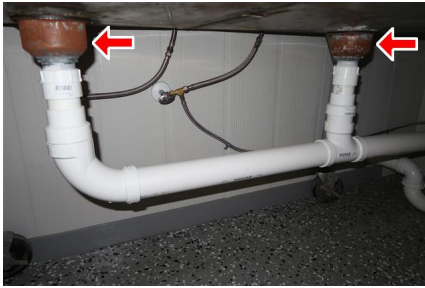
7.9 Item 1 (Picture)

(1) Moderate corrosion present around drain traps at ground level sink.

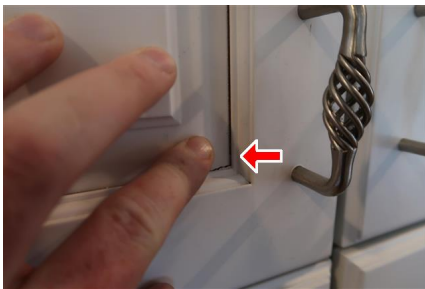
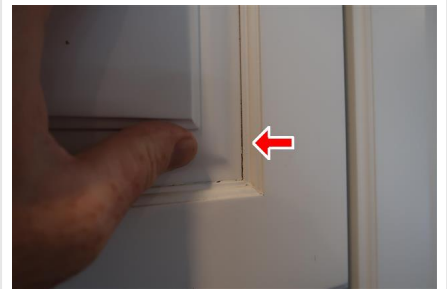
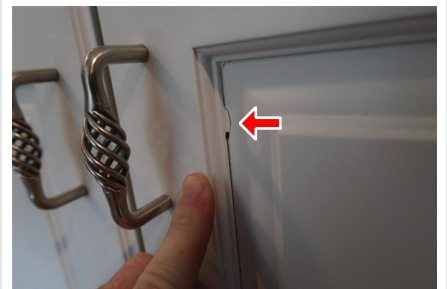
(2) In the kitchen, the cabinets had visible minor damage.

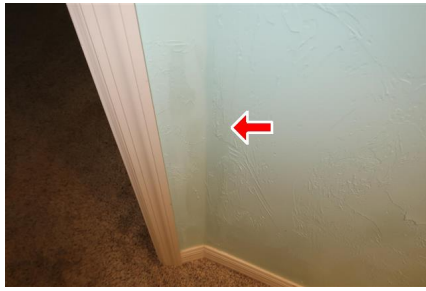
8.1 Item 1 (Picture)

Paint maintenance needed at wall in master bathroom.

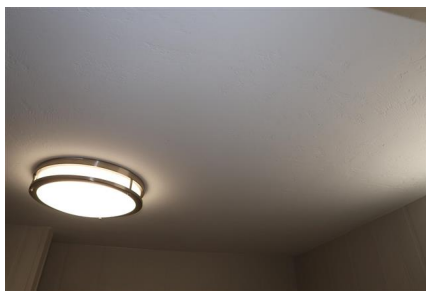
8.5 Item 1 (Picture)

Although the ground level bathroom had a window, no exhaust fan was installed to exhaust moist air from bathing activities. This condition is likely to result in excessively high humidity levels during the winter when low outside temperatures make ventilation with an open window uncomfortable. Elevated moisture levels may cause a number of problems, such as corrosion and possible mold growth. Consider installation of an exhaust fan in this bathroom to exhaust moist air to the home exterior. All work should be performed by a qualified contractor.

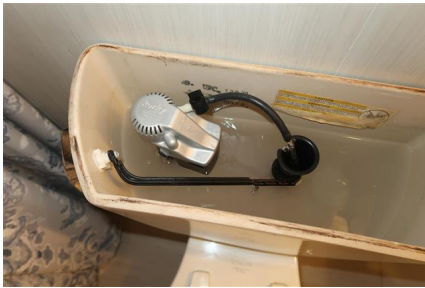
8.9 Item 1 (Picture)

The toilet in the 1st shared bathroom ran continuously. This usually indicates a failed flapper valve, the need for float mechanism adjustment or water leaking from the water tank into the bowl. Under some conditions, in homes with water supplied from a well, this condition can result in running the well dry and burning out the pump, requiring expensive repair. You should be diligent in maintaining toilet tank mechanisms in the future to avoid pump damage.

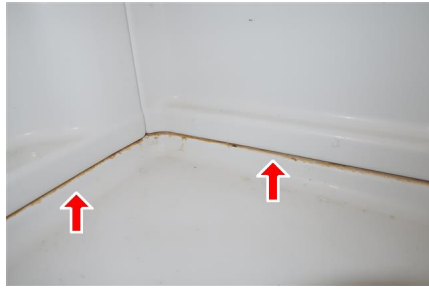
8.11 Item 1 (Picture)

At the ground level bathroom, sealant at the tub/shower was old and had visible discoloration consistent with microbial growth. The Inspector recommends that this sealant be removed and replaced to help prevent the development of unhealthy conditions.

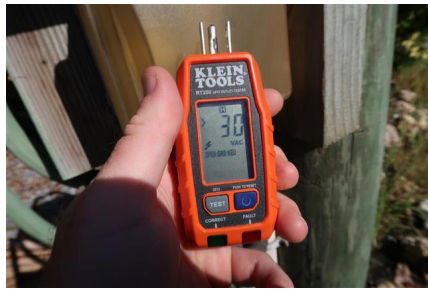
10.16 Item 1 (Picture)

An exterior electrical receptacle at the dock had an open ground neutral. The Inspector strongly recommends evaluation and correction as necessary by a qualified electrical contractor.

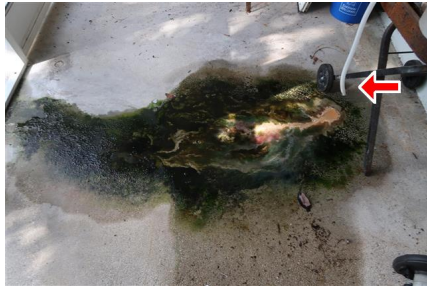
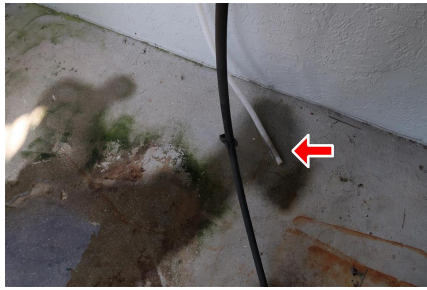
(1) Mini split system condensate line is draining at screened porch at rear of dwelling causing staining and microbial growth. Repairs should be made by a qualified contractor.

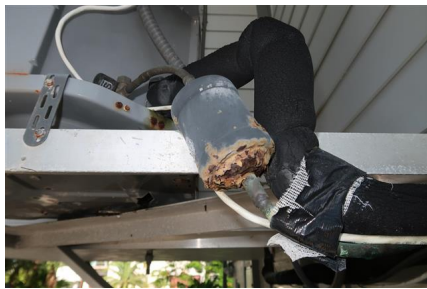
13.0 Item 4 (Picture)

(2) The condenser units freon filter exhibited signs of severe corrosion. Repairs should be made by a qualified contractor.
