# Inspection Report

## Visionary Holdings

7142 Shannon Blvd

Fort Myers FL 33908

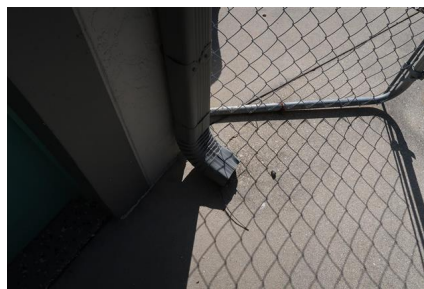
**1.5 Item 2 (Picture)****1.6 METAL ROOF**

One or more downspouts discharged roof drainage next to the foundation. This condition can effect the ability of the soil to support the weight of the structure above and can cause damage related to soil/foundation movement. The Inspector recommends the installation of downspout extensions to discharge roof drainage a minimum of 6 feet from the foundation.

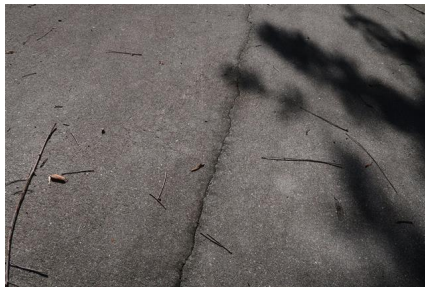
4.2 Item 2 (Picture)

Significant cracks visible in the driveway should be filled with an appropriate sealant to avoid continued damage to the driveway surface from freezing moisture.

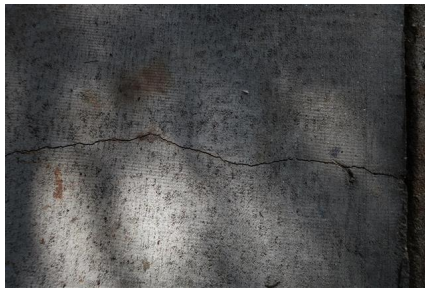
4.6 Item 2 (Picture)

(1) Significant cracks visible in the screened porch should be patched with an appropriate sealant to avoid continued damage from freezing moisture.

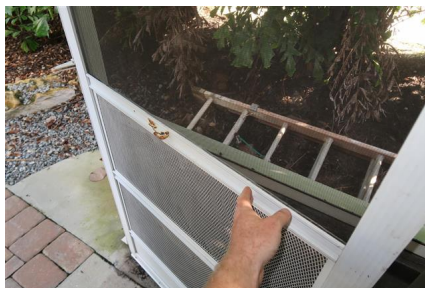
4.6 Item 7 (Picture)

(3) Screened porch doors were missing hardware allowing them to self close. Repairs should be made by a qualified contractor.

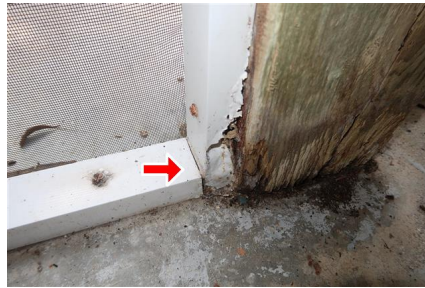
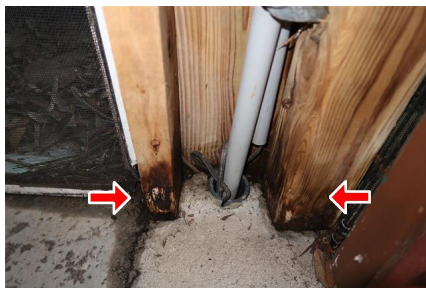
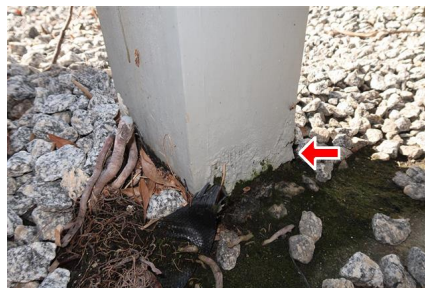
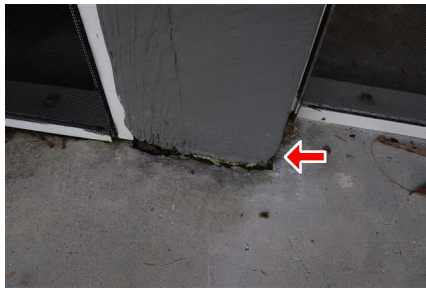
(1) The rear deck framing had advanced decay from contact with soil/moisture. The inspector recommends repair of affected framing to extend the service life of this structure. All work should be performed by a qualified contractor.

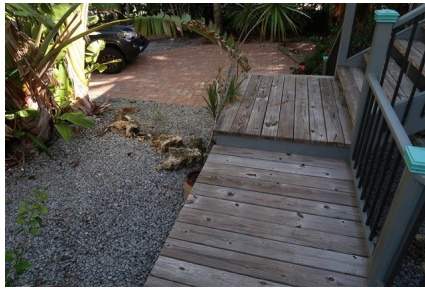
4.8 Item 2 (Picture)

(1) This exterior staircase at front of dwelling had missing handrail. Generally-accepted current safety standards mandate that stairs with 4 or more risers should have a handrail. You should consult with a qualified contractor before the expiration of your Inspection Objection Deadline to discuss options and costs for handrail installation.

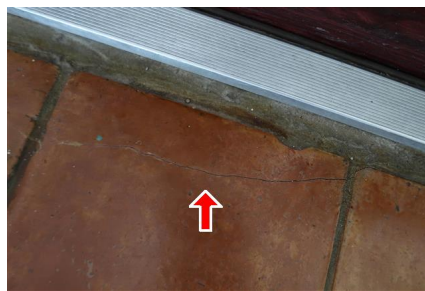
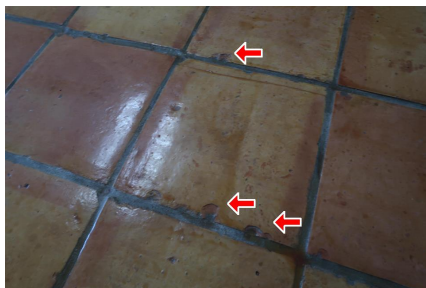
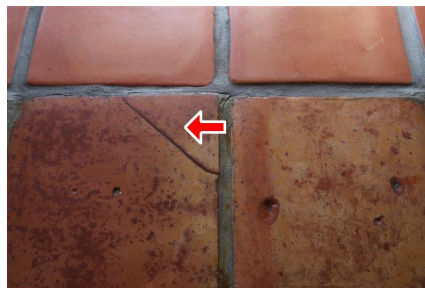
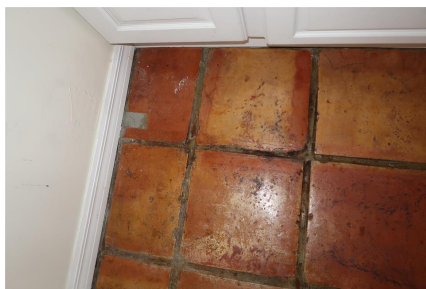
(1) The 2nd floor living area had cracked or damaged floor tiles. You should ask the seller if spare tiles are available as matching replacements. The Inspector recommends that before the expiration of your Inspection Objection Deadline you consult with a qualified contractor to discuss options and costs for replacement.

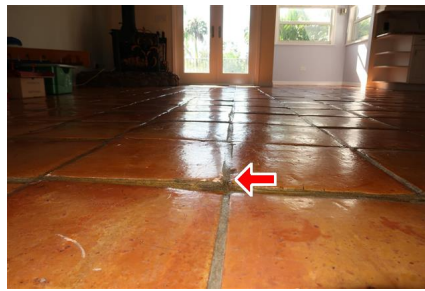
**7.0 Item 10 (Picture)**  
Living room

(2) Floor tiles at 2nd floor living area were poorly installed. A number of uneven tiles were observed.

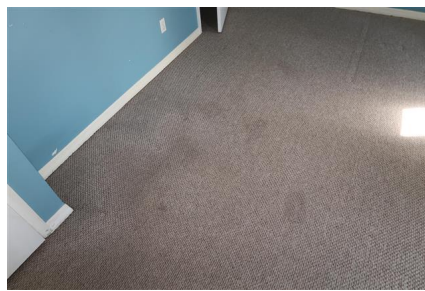
**7.0 Item 13 (Picture)**  
2nd shared bedroom

(3) Carpeting in the home was severely worn and stained. The Inspector recommends that before the expiration of your Inspection Objection Deadline you consult with a qualified contractor to discuss options and costs for replacement.

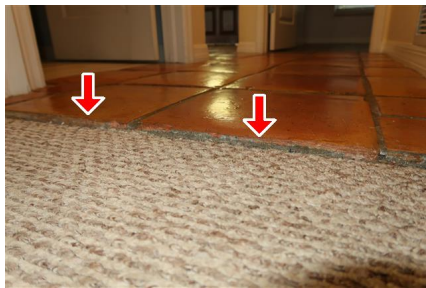
**7.0 Item 14 (Picture)**

(4) Transition strip needed between 2nd shared bedroom and hallway.

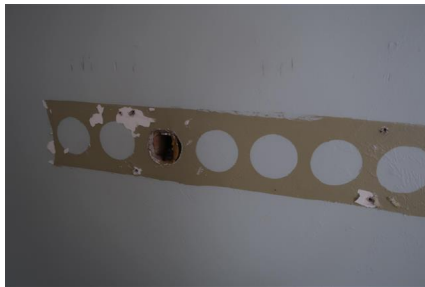
**7.1 Item 6 (Picture)**  
Living room

(2) Walls in the home showed general moderate damage. Repairs should be made by a qualified contractor.

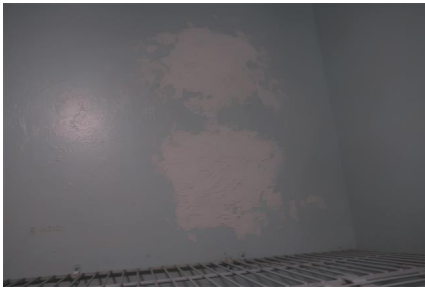
7.1 Item 9 (Picture)

(3) Drywall patches installed in the 2nd shared bedroom were poorly executed.

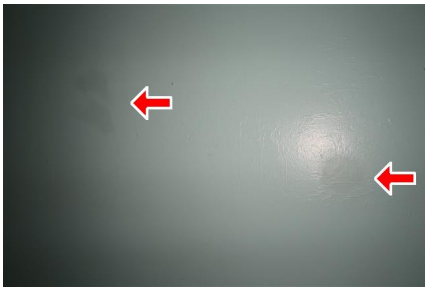
7.1 Item 10 (Picture)

(4) Drywall patches installed in the master bedroom were poorly executed.

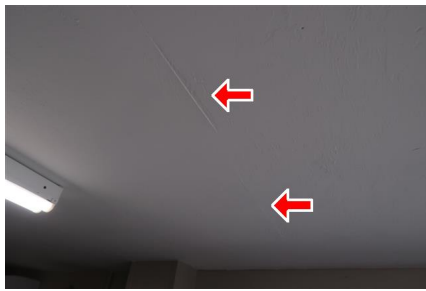
**7.2 Item 2 (Picture)**  
Ground level living area

(2) Drywall seams were visible in the ceiling at areas of the dwelling.

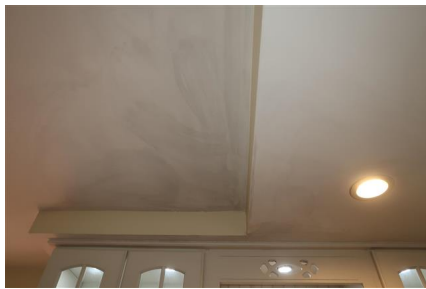
**7.2 Item 4 (Picture)**

(3) Paint maintenance needed at ceiling in kitchen.

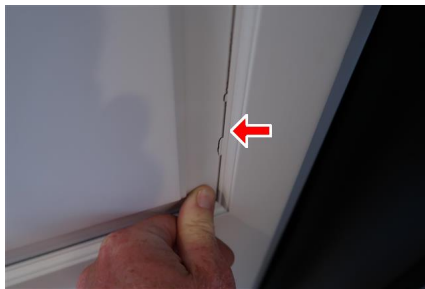
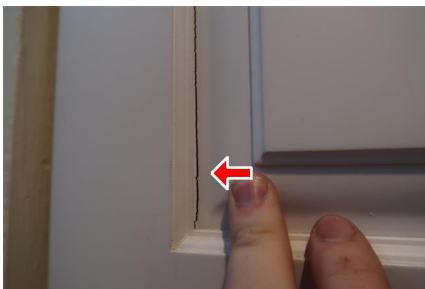
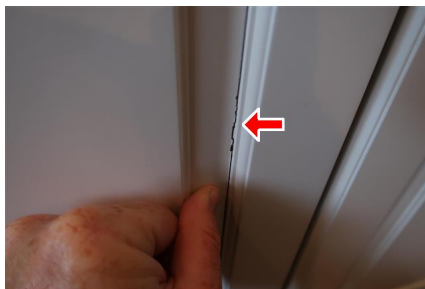
(2) In the kitchen, the cabinets had visible minor damage.

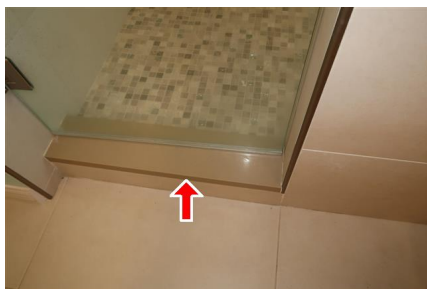
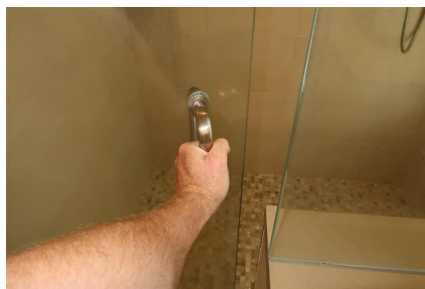
Glass shower door in master bathroom was difficult to operate. Door should be readjusted by a qualified contractor.

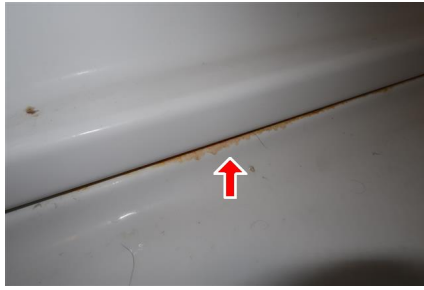
8.11 Item 2 (Picture)

At the ground level bathroom, sealant at the tub/shower was old and had visible discoloration consistent with microbial growth. The Inspector recommends that this sealant be removed and replaced to help prevent the development of unhealthy conditions.

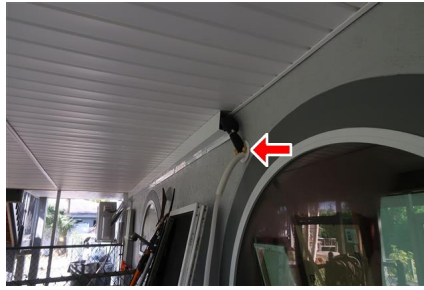
13.0 Item 2 (Picture)

(1) Mini split system condensate line is draining at screened porch at rear of dwelling causing staining and microbial growth. Repairs should be made by a qualified contractor.
